MATHEMATICAL SIMULATIONS OF REAL-WORLD PEDESTRIAN-VEHICLE COLLISIONS

Paper No. 05-285

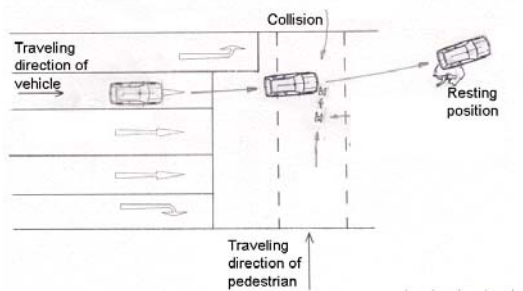
A male pedestrian was hit with an estimated impact velocity of 45-50km/h by a VW Golf in an intersection. The intersection consisted of three lanes for forward traffic and one lane for left turning traffic. Vehicles were stationary in the inner forward running lane and the case vehicle was in the forward running lane next to the left turning lane (Figure 1). The driver of the case vehicle saw from a distance the light change from red to green and entered the intersection at a travel speed of 45-50km/h. A pedestrian was walking quickly across the intersection, hidden from the case vehicle by the stationary vehicle. The pedestrian was hit by the right front of the case vehicle, which started to brake at impact.

Figure 1. The intersection in Case 1 where a VW Golf struck a pedestrian. The pedestrian was hidden from the view of the driver in the case vehicle by stationary vehicles in the forward running lanes.

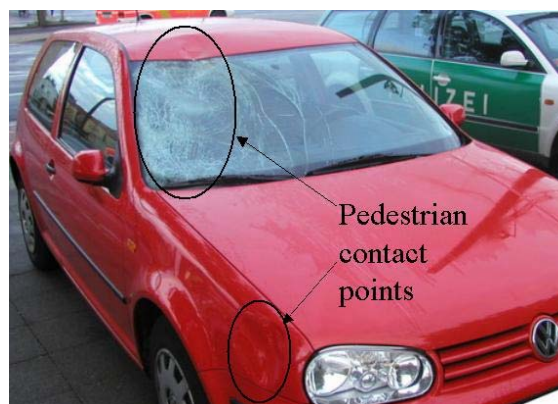
The impacting vehicle was a 2000 2-door VW Golf. Marks on the vehicle showed that the pedestrian struck the front right quarter panel, the right side of the windshield and the right side of the roof adjacent to the windshield (Figure 2). The pedestrian was thrown 9.4m from where the impact occurred. The range of thrown distance was estimated to be ± 1 m.

Figure 2. The impact locations of the male pedestrian on the front right quarter panel, windshield and roof on the VW Golf in Case 1.

The VW Golf was generated using 15 ellipsoids. The front-right quarter panel, a-pillar and roofline of the vehicle were modelled in detail. Impact velocity of 11.8m/s, braking prior to impact and a braking distance of 13.3m were applied. The pedestrian's initial posture was in a walking stance with the left leg slightly in front of the right. The pedestrian was given an initial velocity of 3m/s.

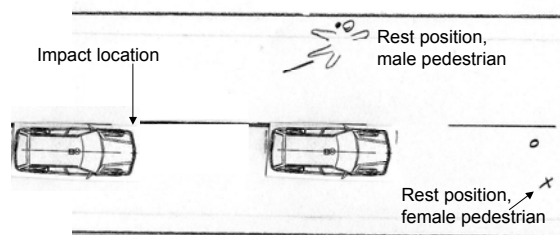
Two pedestrians, one male and one female (denoted Case 2a and 2b), were hit with an estimated impact velocity of 43-49km by a BMW when they appeared suddenly from between parked cars in the dark. The male pedestrian was hit by the left front and the female pedestrian was hit by the centre of the case vehicle (Figure 3).

Figure 3. The road where a BMW struck two pedestrians. The pedestrians appeared suddenly from between parked cars and attempted to cross the street in Case 2.

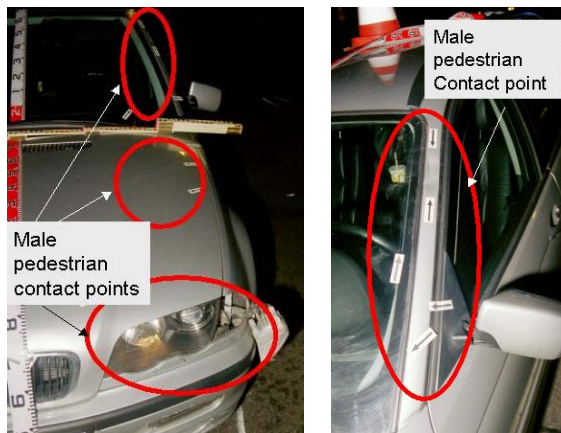
The male pedestrian impacted the left a-pillar; the front left side of the hood and the area above the left side of the head-lamp (Figure 4). The male pedestrian was thrown 8.5m from where the impact occurred. The range of thrown distance was estimated to be ± 1 m. The female pedestrian hit the centre of the hood (Figure 4) and was thrown approximately 15m from where the impact occurred. The female pedestrian rose immediately after having landed on the ground and there were no marks that could further verify the orientation of the pedestrian in her rest position. The range of thrown distance was estimated to be ± 2 m.

Figure 4. The impact locations of the male pedestrian on the BMW in Case 2.

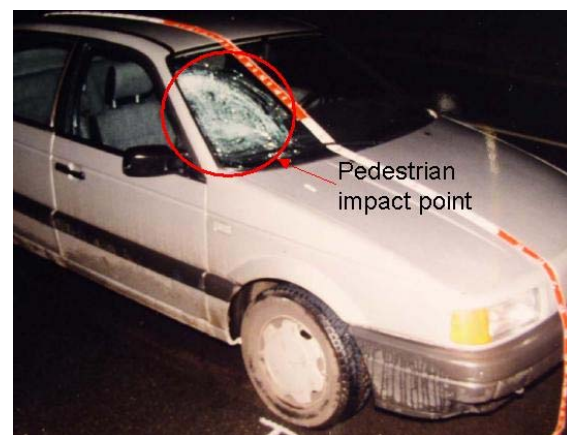
The male pedestrian was hit by the right side of the windscreen, the front right side of the hood and the on the right side of the bumper (Figure 6). The male pedestrian was thrown 10.3m from where the impact with the vehicle occurred. The range of thrown distance was estimated to be ± 1 m.

Figure 7. The impact locations of the pedestrian on the VW Passat in Case 3.

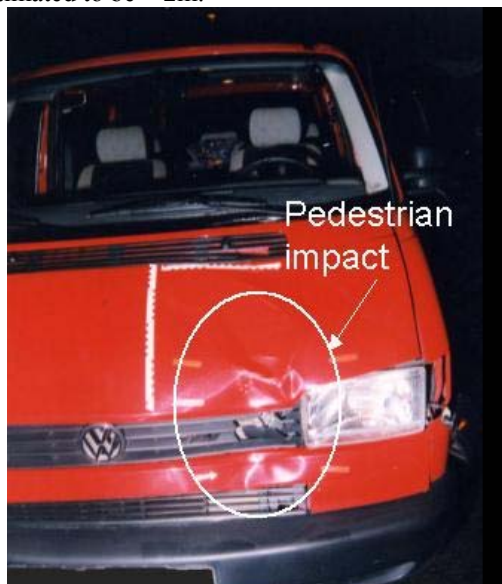
Marks on the vehicle showed that the female pedestrian hit the left side of the front (Figure 9). The female pedestrian was thrown approximately 12.5m from where the impact occurred. The pedestrian rose immediately after having landed on the ground and there were no marks that could further verify the orientation of the pedestrian in her rest position. The range of thrown distance was estimated to be ± 2 m.

Figure 9. The impact locations of the female pedestrian on the VW Caravelle in Case 4.

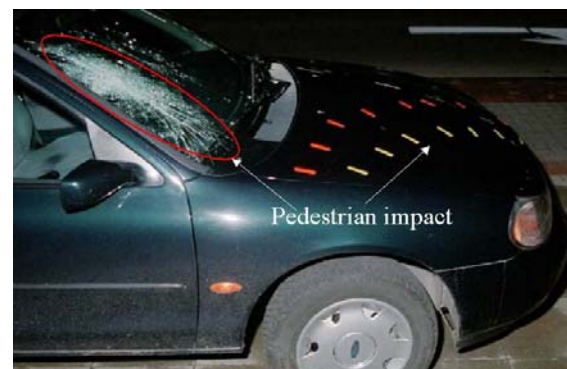
Marks on the vehicle showed contact with the vehicle at the windshield and the hood. The pedestrian was struck by the centre front of the vehicle, slid to the right along the hood and hit the head on the windshield (Figure 11). The male pedestrian was thrown 7.8m from where the impact occurred. The range of thrown distance was estimated to be ± 2 m. According to a witness the pedestrian was seen to run across the street.

Figure 11. The impact locations of the male pedestrian on the Ford Mondeo in Case 5.

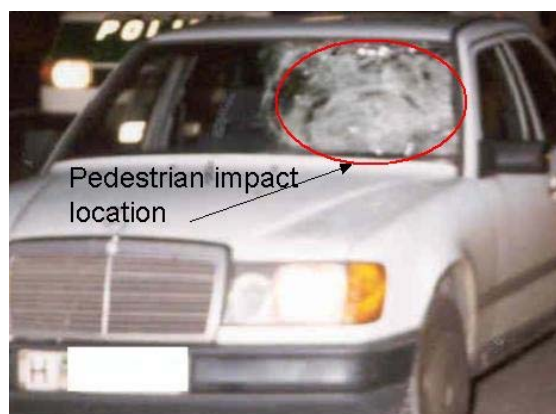
Marks on the vehicle showed that the female pedestrian hit the left side of the windshield (Figure 8). The female pedestrian was thrown approximately 9-14m from where the impact occurred.

Figure 13. The impact location of the female pedestrian on the Mercedes in Case 6.

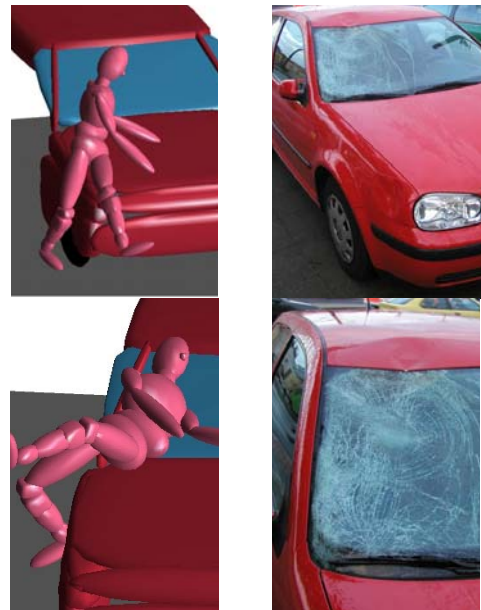
Figure 15 shows photos of the impacted vehicle and images from the simulations of Case 1 where the male pedestrian impacted the side of the vehicle. The simulated throw distance was 9.8m forward of the vehicle with the impact velocity of 45km/h. Head impact occurred at similar spot on the vehicle as in the real-world case.

Figure 15. Photos of the impacted VW Golf and images from the simulation of the male pedestrian hit by the vehicle with an impact velocity of 45km/h, Case 1.

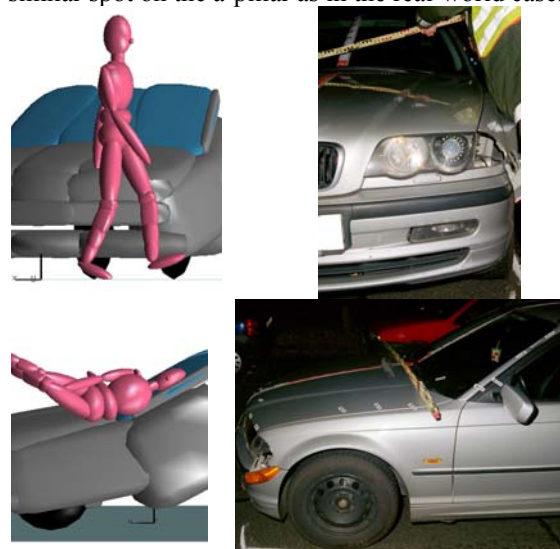
Figure 16 shows photos of the impacted vehicle and images from the simulations of the male pedestrian Case 2a (simulated with the 95th percentile male model) impacting the front left side of the vehicle. The simulated throw distance was 9.3m from the vehicle and the impact velocity used in the simulation was 46km/h. Head impact occurred at similar spot on the a-pillar as in the real-world case.

Figure 16. Photos of the impacted BMW and images from the simulation of the male pedestrian hit by the vehicle with an impact velocity of 46km/h, Case 2a.

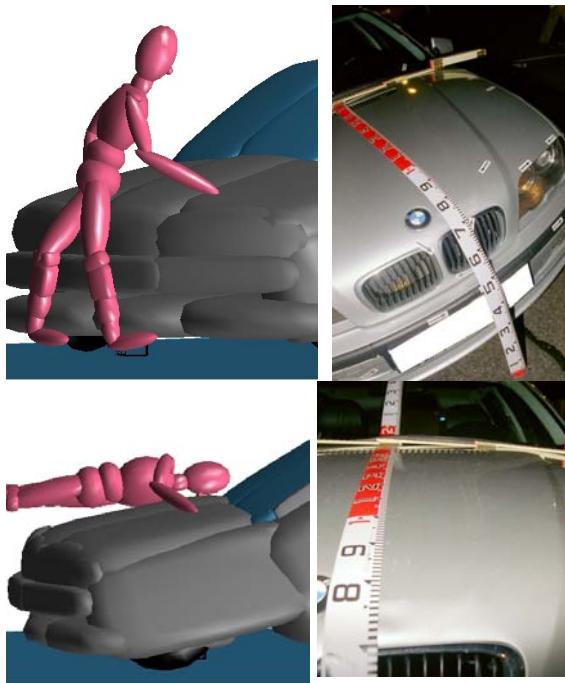
Figure 17 shows photos of the impacted vehicle and images from the simulation of the female pedestrian Case 2b (simulated with the 5th percentile female model) impacting the centre of the vehicle. The female pedestrian showed no sign of head impact, neither from marks on the vehicle nor from injuries. The simulated throw distance was 14.7m from the vehicle and the impact velocity used in the simulation was 46km/h.

Figure 17. Photos of the impacted BMW and images from the simulation of the female pedestrian hit by the vehicle with an impact velocity of 46km/h, Case 2b.

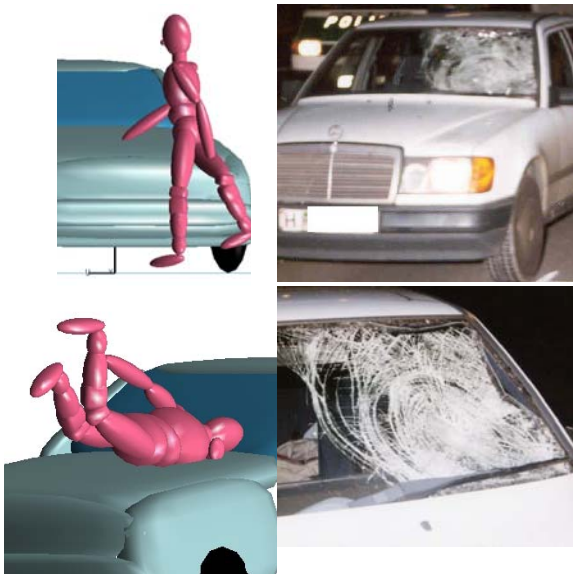
Figure 21 shows photos of the impacted vehicle and images from the simulation of Case 6 where the male pedestrian impacted the front of the vehicle. The simulated throw distance was 10.1m from the vehicle and the impact velocity used in the simulation was 36km/h. Head impact occurred at similar spot on the windshield as in the real-world case.

Figure 21. Photos of the impacted vehicle and images from the simulation of the female pedestrian struck by a Mercedes with an impact velocity of 36km/h, Case 6.

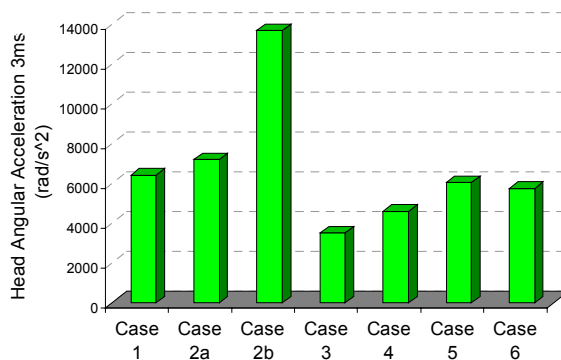
Figure 26. The 3ms head angular acceleration from the simulations of the six cases.

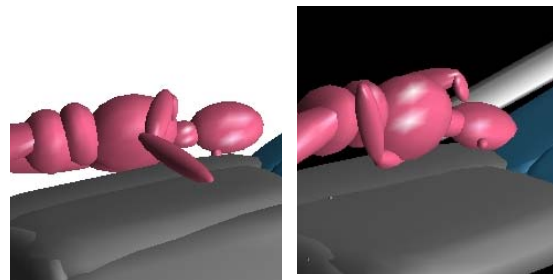
Figure 29. The simulation of the 5th percentile (left) female and the 50th percentile (right) male pedestrian model impacting the BMW with the simulated impact velocity of 46km/h, Case 2a.

In Case 2 there were remarkable differences between the injury outcomes for the two pedestrians. The male pedestrian struck the a-pillar and suffered severe head injuries, whereas the female pedestrian only sustained minor injuries. The pedestrians were struck by the same vehicle and by the same impact velocity. This case highlights the importance of preventing pedestrians from hitting high stiffness structures and the large difference that can occur for a given impact velocity.
